Structural Integrity of Welded Joints: An Investigation of the FPSO Module Stools

The main goal of the present work is the investigation of a construction and integration of topside modules for an FPSO in Brazil. Most of the topside module structure manufacturing was subcontracted to a third-party company in Europe. During assembling work undergoing at the construction site, several structural details nonconformities were reported by the EPC Group quality control team, e.g., misalignment of stiffeners at the diamond plate and stool connections, geometry irregularities, and unexpected thickness changes on the connection of diamond plates with the correspondent I beam flanges of the pancakes, unexpected bevel buttering to correct joint imperfections which presented several weld flaws in it. Topside structures are subjected to cyclic loading during operation, hence, subjected to fatigue loading. The latter is of concern since the structural integrity of the welded joints must be met for the entire life of the FPSO. The EPC Group required an independent appraisal of the welded joints and structural details nonconformities. They also requested an Engineering Critical Assessment (ECA) o

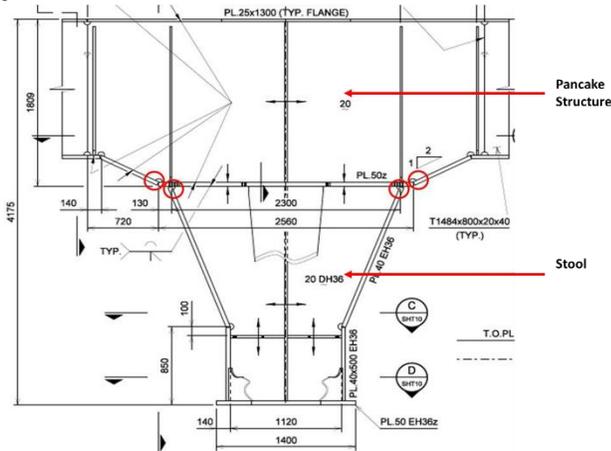
The Engineering Procurement and Construction (EPC) Group presented concerns regarding the structural assembly deviations from the project found during the quality control inspection of the parts manufactured by a subcontractor. A site visit to the construction site revealed the existence of generalized misalignments of stiffeners, that were part of load-carrying cruciform joints at the topside stools, and unexpected thickness changes in the connection joints between the diamond plates and the lower correspondent plate of the I beam of the pancake structures. In Figure 1 it is shown the locations of concern, with joints containing misalignment and thickness changes, Figure 2 shows irregular slope associated with underfill of the welds, and Figure 3 shows typical superior stiffener of cruciform joint misaligned with stool plate center line.

Figure 1 – Pancake structure, stool, and target welded joints marked with red circles.

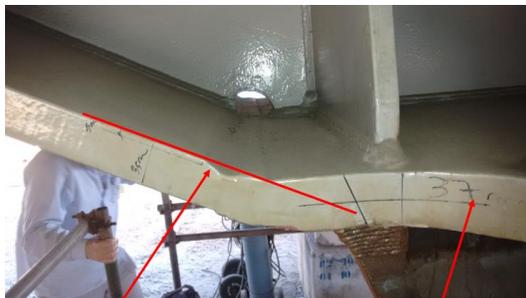
Figure 2 – Change of thickness joint between diamond plate and pancake structure.

As shown Figure 2, the change of thickness joints has presented irregular sloping in accordance with AWS D1.1/D1.1M:2010[18]. In Clause 2, item 2.26 of AWS D1.1/D1.1M:2010, guidance is given for the thickness transition sloping of axially cyclic loaded primary members of non-tubular joints, and there are references to the acceptable joint configurations for the transition of butt joints in parts of unequal thickness.

A close evaluation at the as built geometry of the thickness transition joints under investigation shows that the sloping prepared during manufacturing by the subcontractor did not follow the recommendations given in AWS code D1.1/D1.1M:2010. For the sake of illustration, figure 9 shows a paper replica of a typical change of thickness joint found on the topsides. It can be noted that the slope prepared for the joint is in the top side of the I-beam plate, and it is located at the smallest thickness side of the joint. It is impossible to verify from the replica if sloping was prepared on the thicker plate from the diamond plate side. However, according to AWS D1.1/D1.1M:10, the slope shall be made in the thicker plate, and in this configuration, on the underside of the plate. Figure 9 also shows an overall underfill on the topside of the welded joint and underfill on the opposite side of the joint.

- Nonstandard thickness change joints, non-conform with AWS D1.1/D1.M:2010, shall be repaired to allow reliable ECA fatigue assessment of these joints.

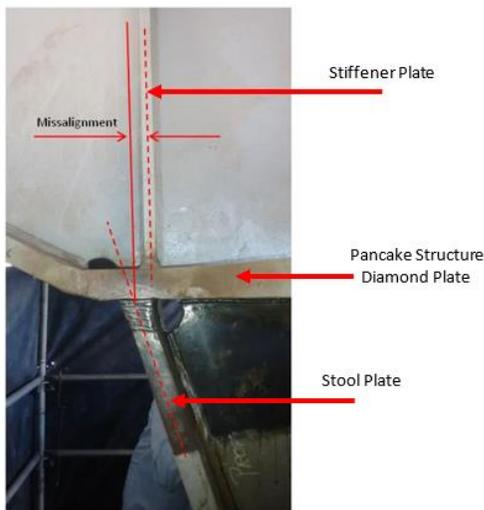
Figure 3 – Misalignment between stool plate and stiffener above the diamond plate.

The main concern regarding the cruciform joints was the effect of the misalignment of the stiffener above the diamond plate over the combined fatigue-fracture behaviour of the joint containing small discontinuities. Similarly, for the butt welds with the change of thickness, the effect of the subcontractor's non-standard thickness transition over the joints' fatigue-fracture behaviour. The local stresses and the fatigue loads considered in the ECA were the as-built fatigue load spectrum of the joints estimated by the EPC Group engineering team. Initial flaw sizes considered were the limits of detectability of the NDE technique in accordance

- All stiffeners above the diamond plates in the stool cruciform joints with as-built misalignment above 2mm shall be repositioned to guarantee the fatigue life estimates shown in the ECA assessment.

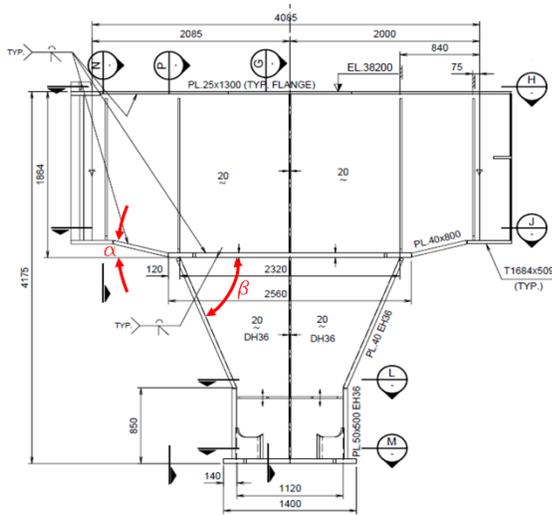
Figure 5 – Angular misalignment in the as built condition.

STOOL	α	β
M08-Member 024-275	14°	68°
M09-Member 023-103	26,6°	68,7°
M09-Member 021-101	26,6°	68,7°
M08-Member 023-267	14°	68°
M10-Member 023-103	14°	68°

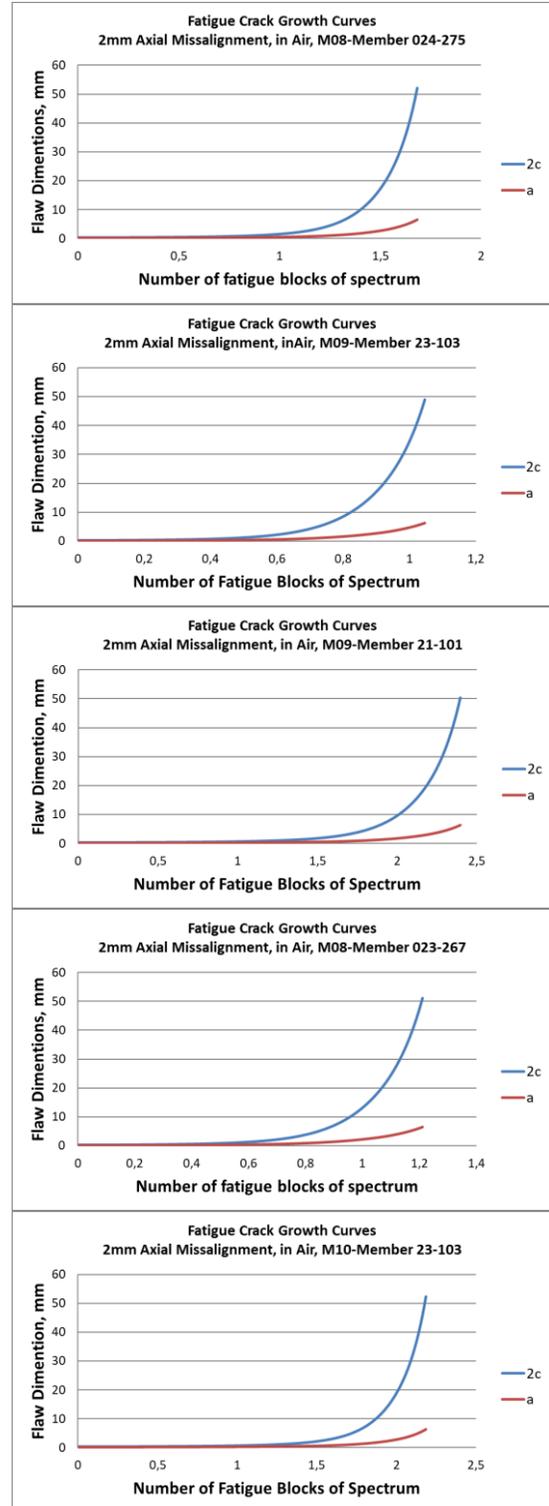
Further assessments were carried out considering that all joints will be repaired, see Figure 7, with an axial misalignment up to 2mm maximum. The angular misalignment and other ECA parameters were the same as in the assessments shown in Figure 6. The results show that after mitigation measures are undertaken to correct the axial misalignment, all joints have acceptable fatigue lives with failure predicted above the fatigue life of the joints represented as 1.0 in the horizontal line.

Figure 7 – Fatigue-fracture assessment results for all joints with misalignment corrected to 2mm and free corrosion in air conditions.

Typical initial values of M_{km} solution for the cruciform joint is 1.1930 for 32mm misalignment joint and 1.1788 for the 2mm misalignment. These changes in M_{km} values associated with the bending moment stresses due to misalignment are the main driven parameters for the significant changes in

- ECA carried out in the stool cruciform joints demonstrated the need for repair work to correct axial misalignment to a maximum of 2mm for all topside joints.

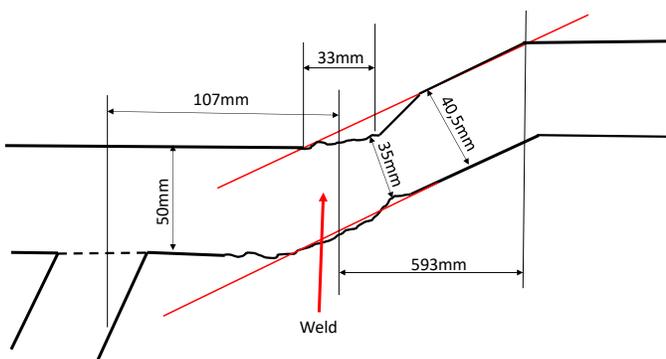
Figure 9 – Replica of a typical thickness change welded joint.

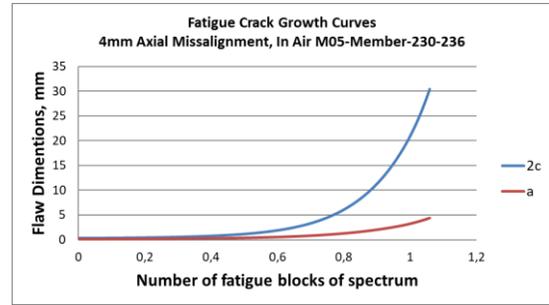
The results shown in Figure 10 lead to the conclusion that the change of thickness joint has estimated fatigue-fracture life above the service life expected, represented by the number 1 on the horizontal axis of the chart.

Figure 10 – Fatigue-fracture assessment results for typical transition thickness joint, with maximum misalignment set to 4mm.

Finally, it is necessary to perform repair intervention to correct the geometry of the change of thickness joints to use BS7910's M_{km} solutions, as shown in the ECA assessment in figure 10.
