Structural Integrity of Welded Joints: An Investigation of the FPSO Module Stools

The main goal of the present work is the investigation of a construction and integration of topside modules for an FPSO in Brazil. Most of the topside module structure manufacturing was subcontracted to a third-party company in Europe. During assembling work undergoing at the construction site, several structural details nonconformities were reported by the EPC Group quality control team, e.g., misalignment of stiffeners at the diamond plate and stool connections, geometry irregularities, and unexpected thickness changes on the connection of diamond plates with the correspondent I beam flanges of the pancakes, unexpected bevel buttering to correct joint imperfections which presented several weld flaws in it. Topside structures are subjected to cyclic loading during operation, hence, subjected to fatigue loading. The latter is of concern since the structural integrity of the welded joints must be met for the entire life of the FPSO. The EPC Group required an independent appraisal of the welded joints and structural details nonconformities. They also requested an Engineering Critical Assessment (ECA) o

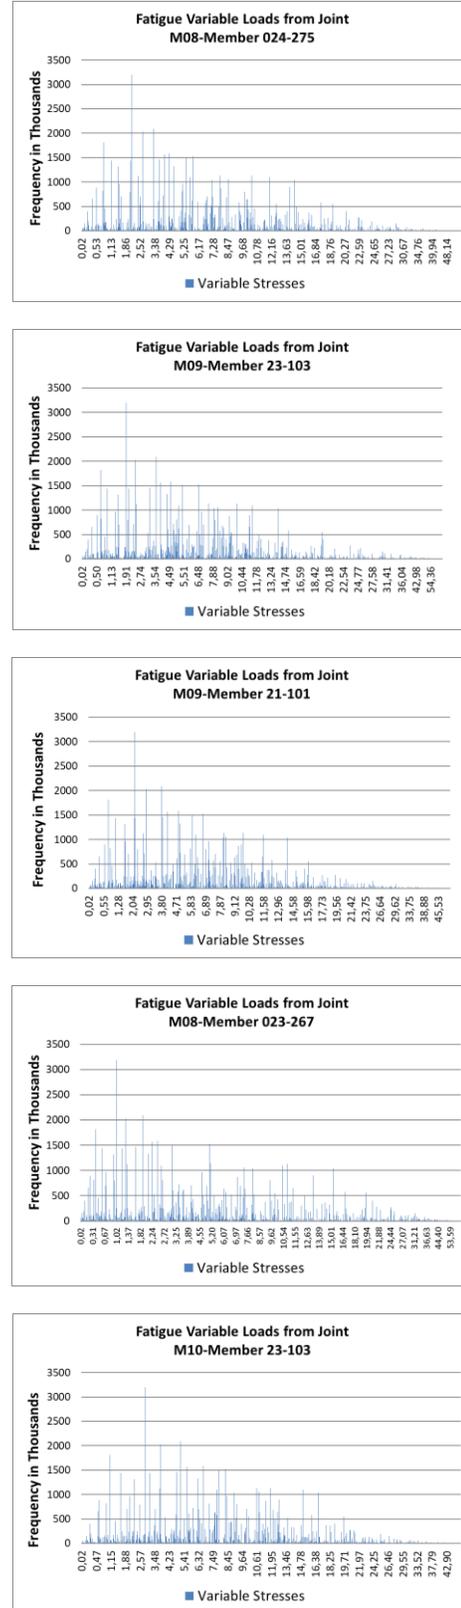
Figure 4 – Fatigue load variable loads spectrums.

Figure 4 shows the fatigue variable loads provided by the EPC Group engineering team.

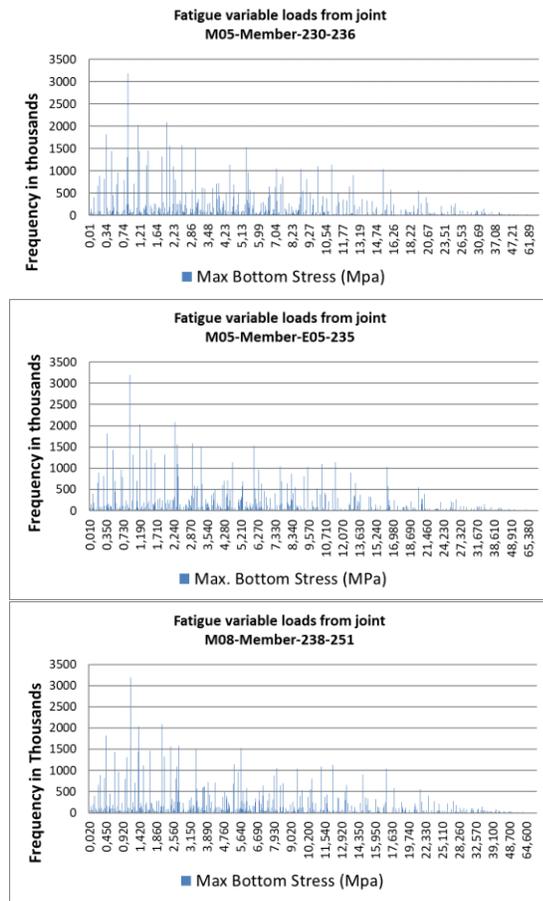
Figure 8 – Fatigue load variable loads spectrums provided by EPC Group engineering team for the change of thickness joints.

Three joints, as shown in Figure 2, were assessed to estimate their fatigue lives, subjected to the fatigue loading spectrum for each joint and considering an existing undetectable surface flaw located at the weld toe as reported in section 2.3, the boundary conditions used in the ECA were the same as those used in the cruciform joints. The EPC Group engineering team provided the fatigue variable loads shown in Figure 8, for each of the joints investigated.
